RESEARCH ARTICLE

ANALYSIS OF MORTAR SAMPLES AND MINERAL COMPOSITION FROM DEIR EL-KAHF, JORDAN

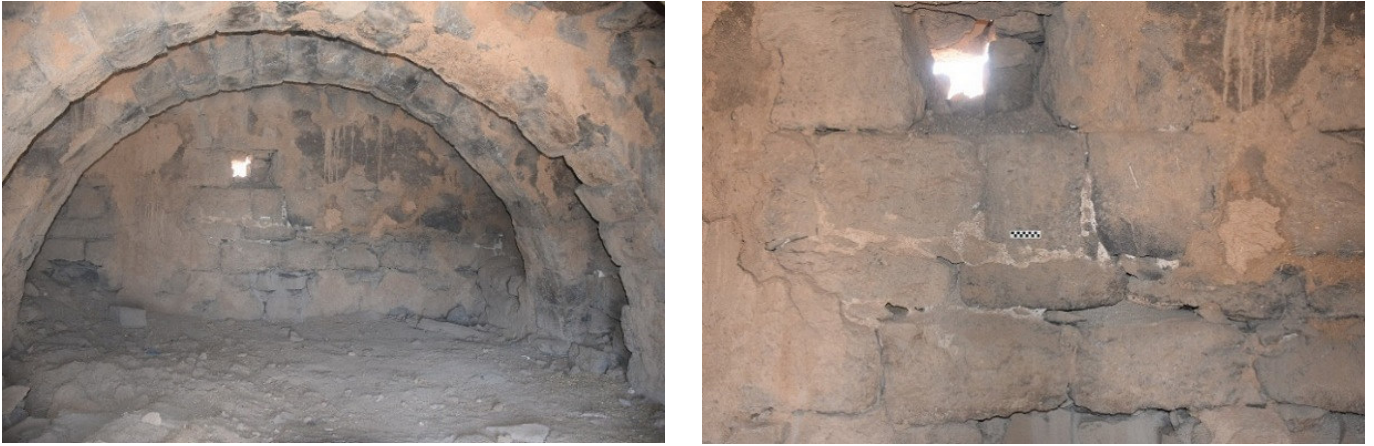
Figure 2. Samples from site 1, S1a (left) and S1b (right), obtained from the room located at the southernmost corner of the site, characterized by two arches. The sample was taken from the highest point of the room to ensure a representative and uncontaminated sample.

The samples (Figures 2–4) will undergo laboratory analysis to determine their mineralogical and chemical compositions, shedding light on the construction techniques and materials employed at the site. Preliminary observations suggest that the lime mortar may contain regional aggregates and additives, reflecting local construction practices. These findings contribute to a deeper understanding of the site's historical usage, architectural evolution, and its role within the broader sociocultural and economic landscape of the region. Future work should focus on further excavation, detailed architectural documentation, and comparative studies of material compositions to contextualize the site's development across different historical periods.

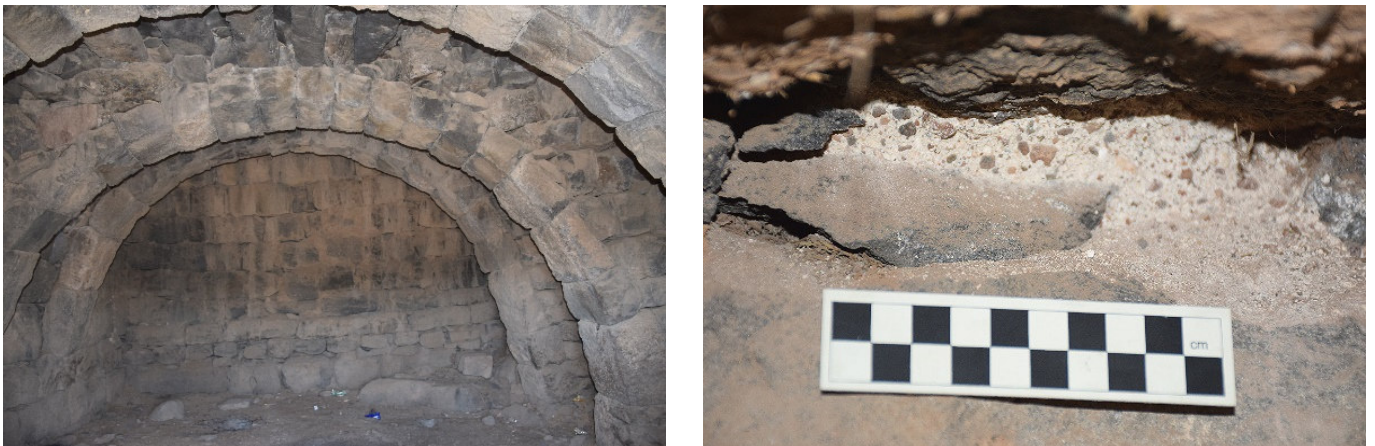
Figure 3. Samples from site 2, S2a (left) and S2b (right), collected from an adjacent room, specifically at the same height level as Sample 1, to minimize the influence of external contaminants such as dust or mud that might have accumulated on the surface.

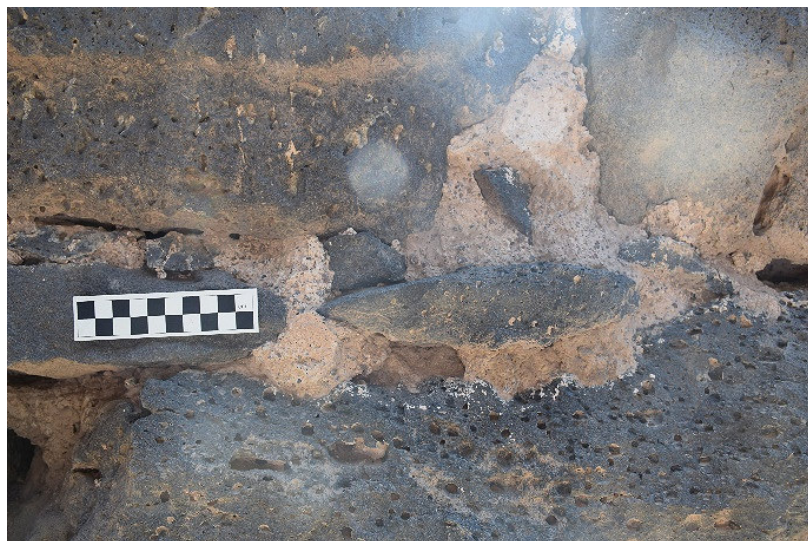
Figure 4. Sample from site 3 (S3), extracted from a semi-demolished room near the water tank at the entrance. This area has not undergone comprehensive excavation, and the sample was collected with caution to preserve its integrity, despite the room's unstable condition.
