## INVESTIGATIONS OF HELLENISTIC MORTAR FROM UMM QAIS (GADARA), JORDAN

**KEYWORDS.** Mortar analysis; SEM-EDS; Gadara; Lime; Restoration.

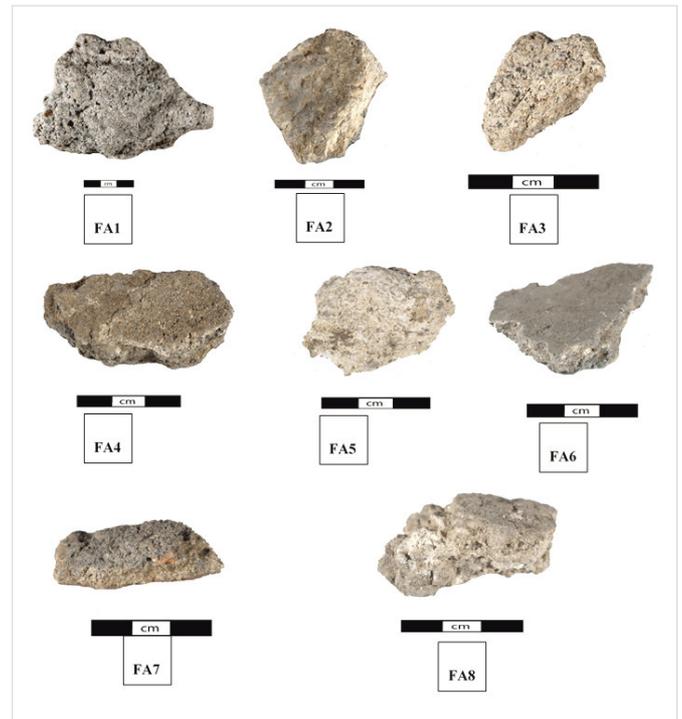
Figure 2. Studied mortar samples.

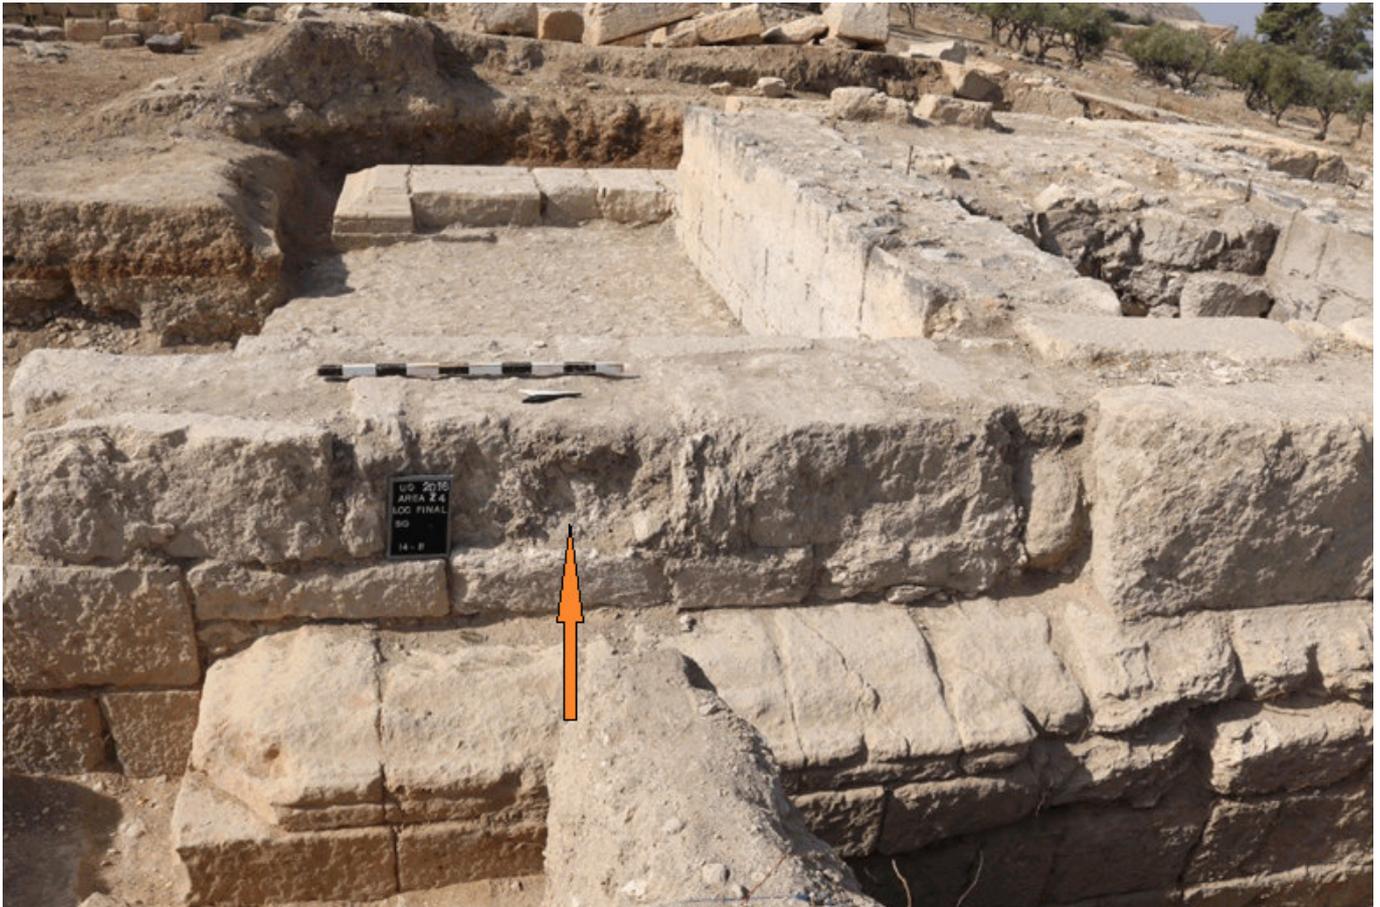
Figure 3. Location of mortar samples.

An important aspect of sampling strategy, significant for determining the chemical composition of mortar, is to have a fresh sample to prevent contamination by mineral accumulation and alteration. In this study, the samples were taken from the open face of the exterior masonry where a facing stone was missing (Figure 3).

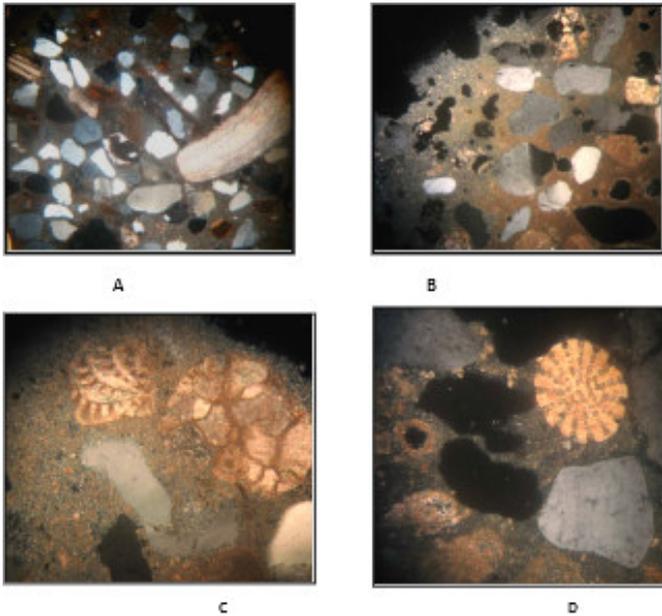
Figure 4. Lime mortar samples FA 1, 4, 6 and 8 show well-sorted quartz and shell fragments (A); quartz with micrite (B); shell fragments, interclast, quartz with micrite (C); and foraminifera, quartz and calcite with micrite (D).

Optical microscopic observations (FA 1–8, as shown in Figure 4) indicate all the mortars are comprised mainly of calcite with some accessory minerals such as quartz and plagioclase. Examination of the mortar samples, showed that the mixture of the mortars was mainly quartz sand with lime as a binder and brick, fine grain size ironstone, quartzite, shell fragments in different kinds, shapes and colors, and charcoal. In addition, organic material (straw) was found in the mixture of some samples. The mortars were very hard and dry and micro cracks were visible on the p surface with rough structure. The thicknesses of the mortar were between 5–10 cm with some up to 15 cm. Not all the fragments were the same thickness, because they came from different locations within the building.

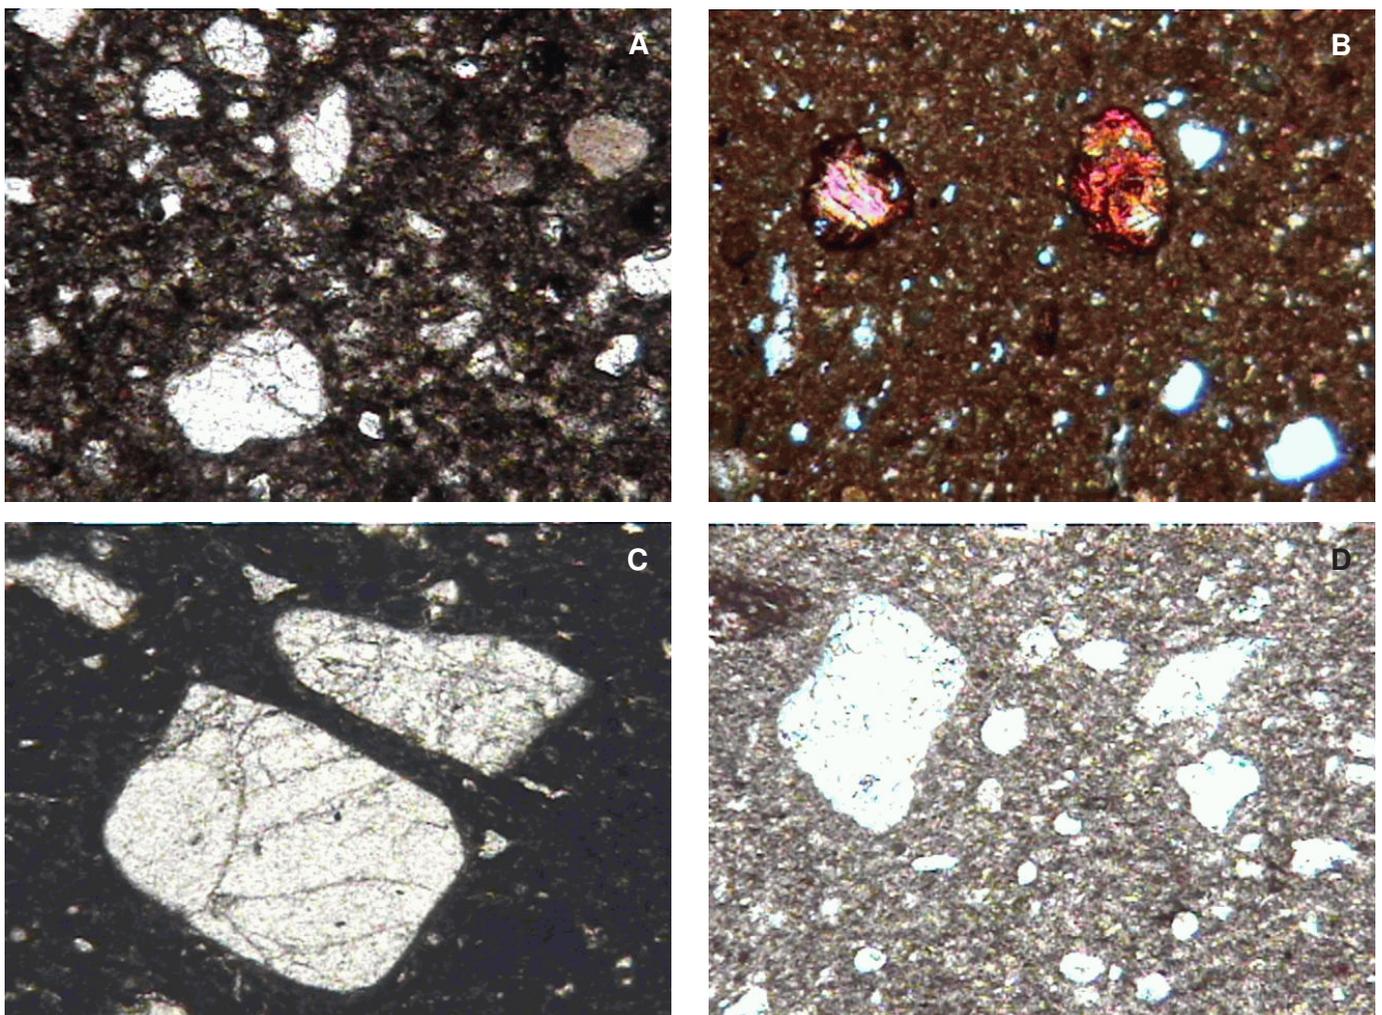
Figure 5. Lime mortar samples FA 2, 3, 5 and 7 (A-D); which contain fine to medium aggregates of quartz, plagioclase, and calcite. The fine-grained to medium-grained aggregates of quartz and plagioclase are embedded in the carbonate matrix.

Thin sections of the samples that were part of the same chemical group show similarity among the minerals included (Figure 5). Quartz predominates. Char-

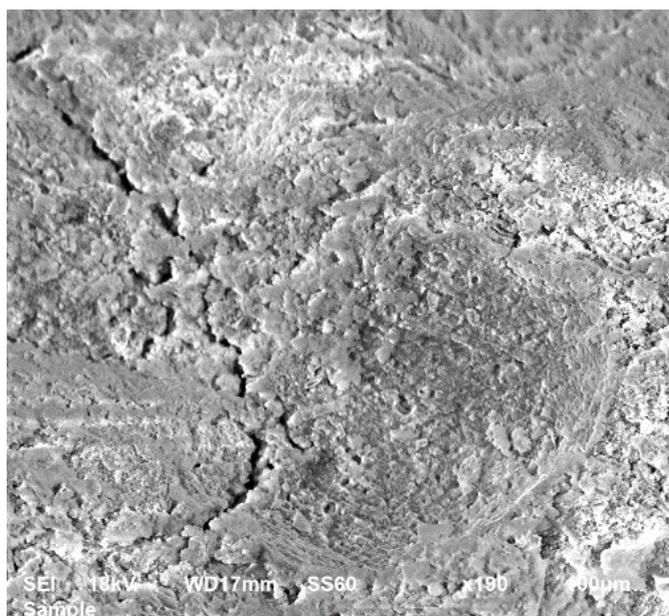
Figure 6. SEM image showing cracks present on the surface of the mortar.

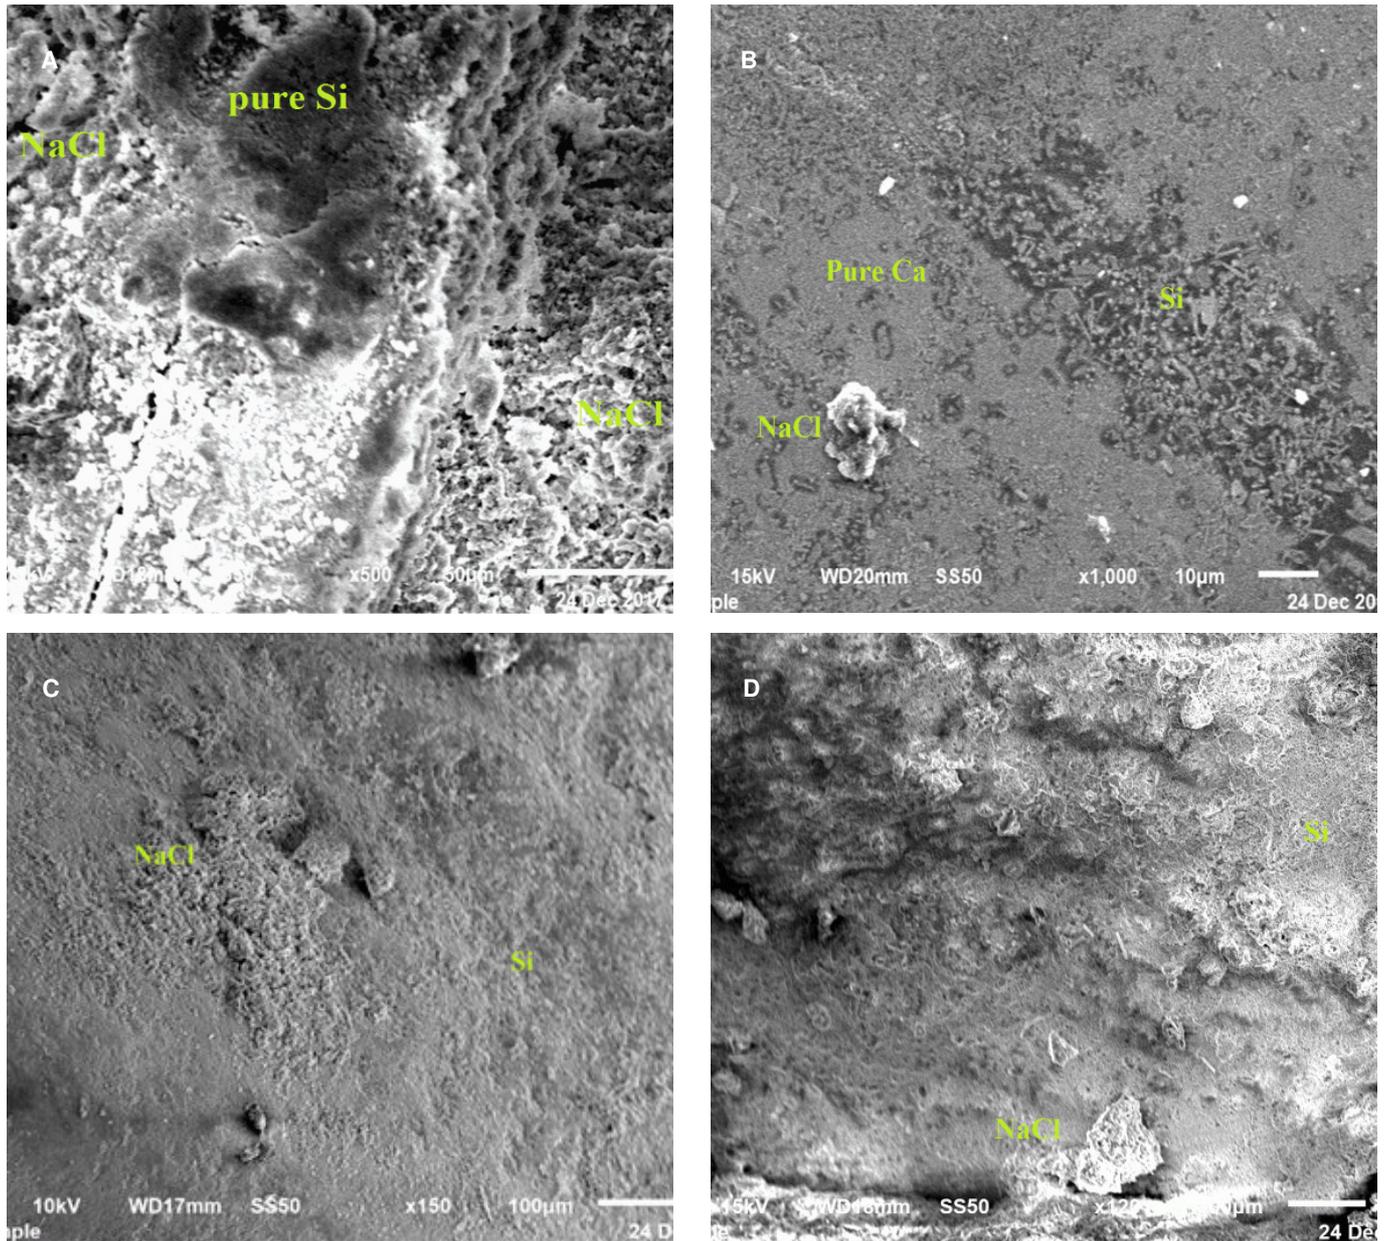
Figure 7. Surface structure of mortar samples FA 1, 4, 6 and 8. A shows the cracks present on the surface; B shows analysis area 1 (yellow arrow) with Ca, Si, S, Al, Mg and Fe present; C shows area 2, containing Ca, S, Si, Al, Mg, Na and Fe; and D shows analysis area 3, containing elements Ca, Si, S, Al, Mg, Fe and Na.

face structures and identified the elements present. All samples and sections were coated with carbon before entering the SEM. Different samples show the same surface characteristics and structures, which gives insight into the deterioration mechanisms and decay that has affected the mortar, as well as allowing the identification of various known salt crystallization formations. Cracks seen due to mechanical stress were visible on some samples, but there were also cracks on the surface (as seen in Figure 6). The surface cracks may be caused by expansion related to certain physico-chemical reactions. Microanalysis showed variation in the microstructure of the surface deterioration in all samples (Figure 7).

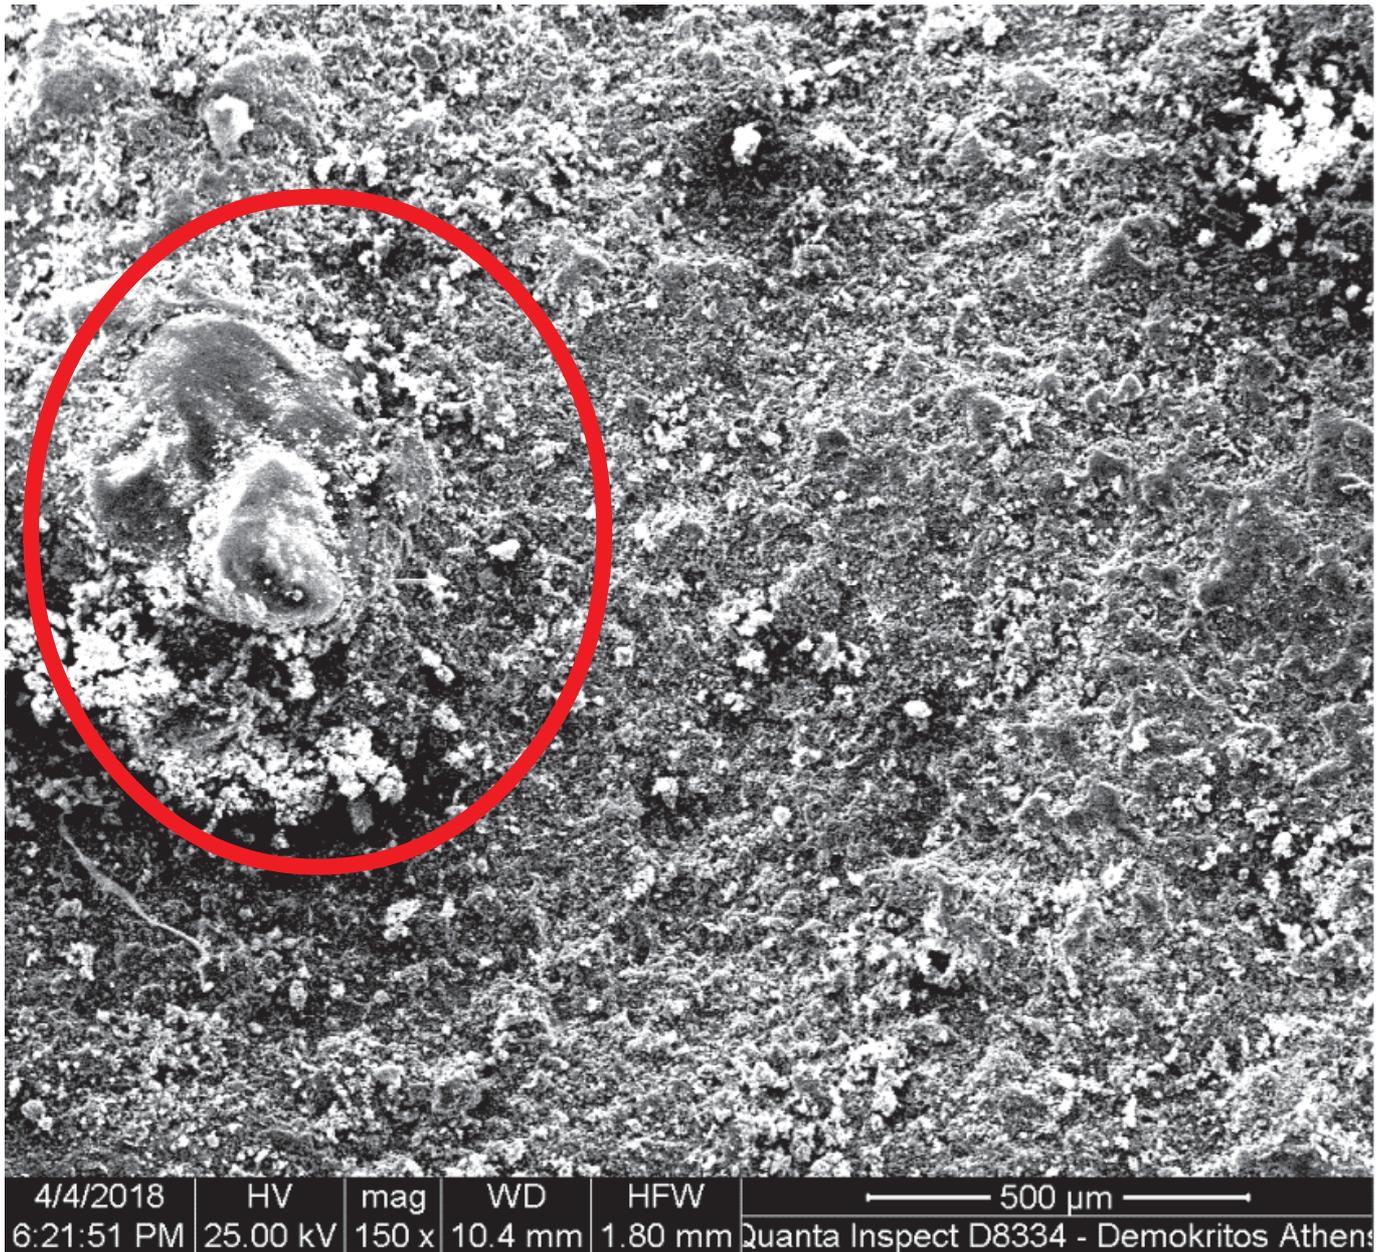
Figure 8. SEM image showing the presence of the white layer on mortar surface.

atmospheric conditions and pollution or as a result of the decomposition of calcium carbonate, sodium sulphate, potassium sulphates, calcium and magnesium. The lime mortars are made of dolomitic lime. This compound may react with sulphate ions in the water. SEM also helped to identify the cause of surface deterioration, such as micro cracking and the presence of various crystalline reaction products (Figure 8).

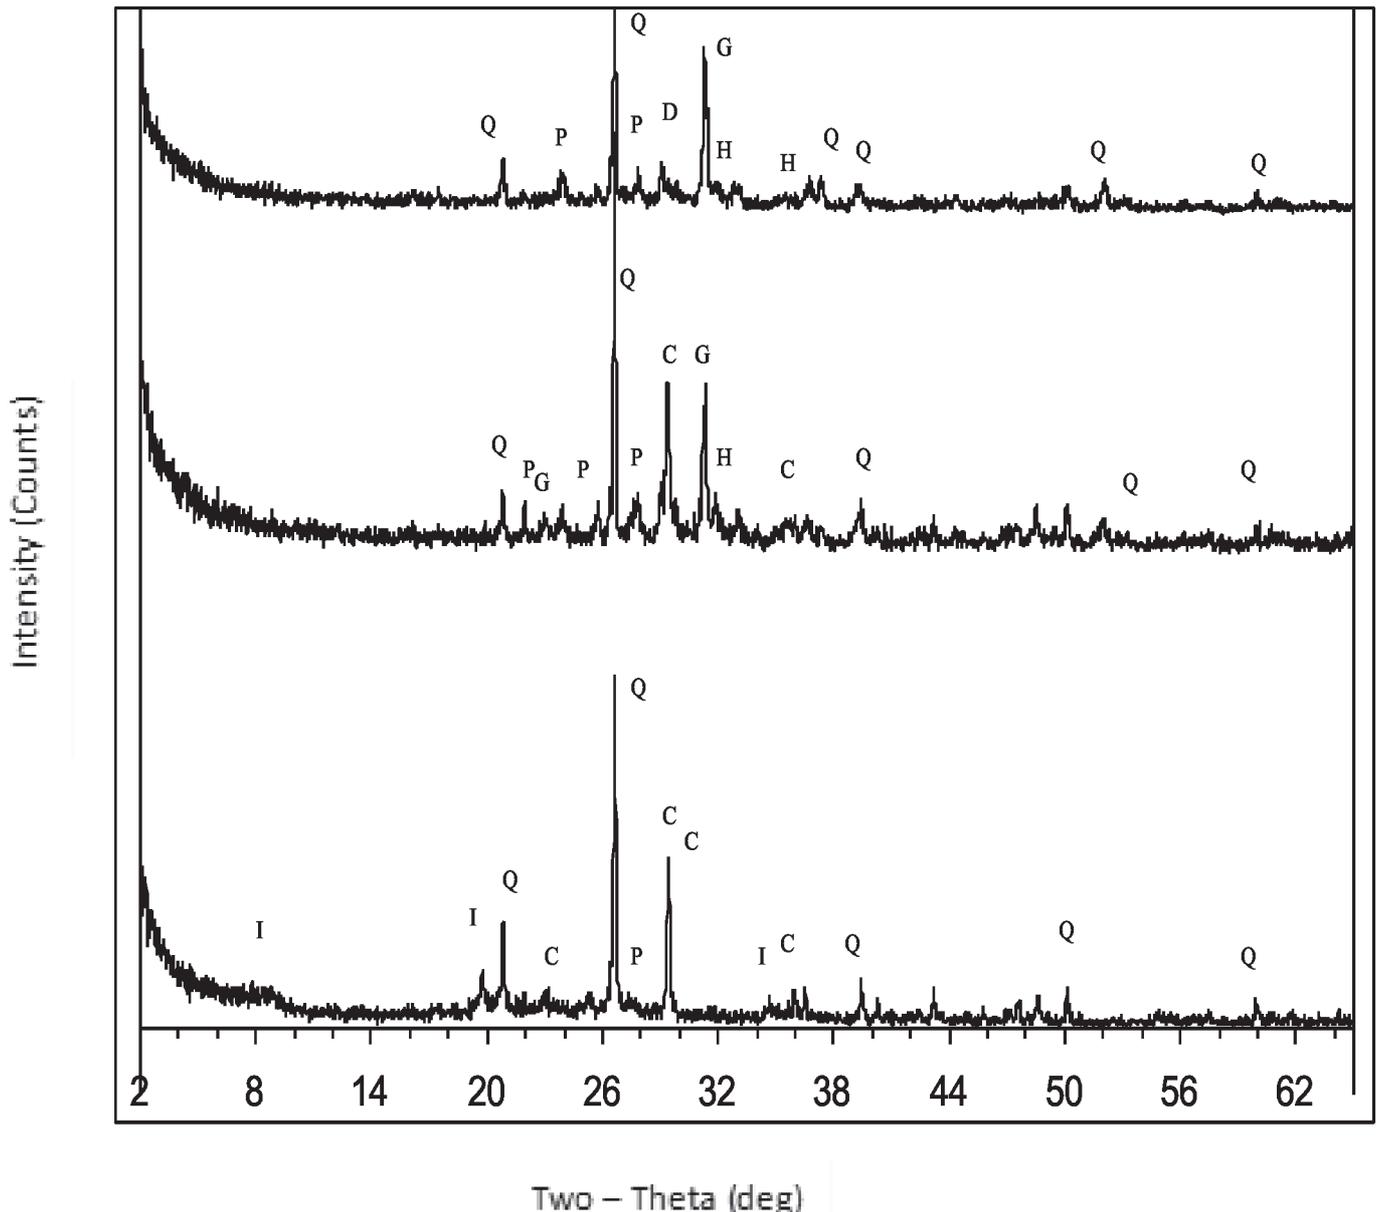
Figure 9. Representative XRD diagrams of mortar samples. The indicated mineral phase are illite (I), quartz (Q), plagioclase (P), K-feldspar (F), calcite (C), sulfur (G) and hematite (H).

diffraction patterns for samples reveals important similarities (Figure 9). The XRD patterns indicate calcite as the main component of the matrix, with the presence of quartz, plagioclase, feldspars, and muscovite as accessory minerals. The XRD analysis of soluble silicates contained in the binder from a significant number of samples reveals hydraulic cement compounds such as calcium silicate hydrate (C-S-H). The presence of C-S-H in mortars can be attributed to the reaction of lime with SiO<sub>2</sub> and Al<sub>2</sub>O<sub>3</sub> in the presence of water; SiO<sub>2</sub> and Al<sub>2</sub>O<sub>3</sub> may be contained in the natural pozzolan, in the finely ground bricks and tiles, as well as in
